**THE CHARACTERIZATION AND ANALYSIS OF ORNAMENTAL
CAST STONE AND STUCCO FROM THE PALACIO ERRÁZURIZ,
BUENOS AIRES, ARGENTINA**

James Valente Banta

A THESIS

Historic Preservation

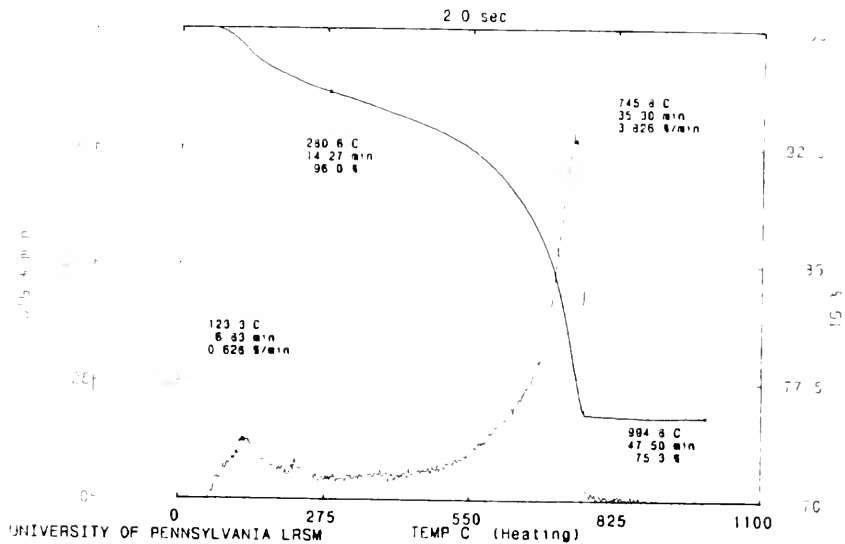
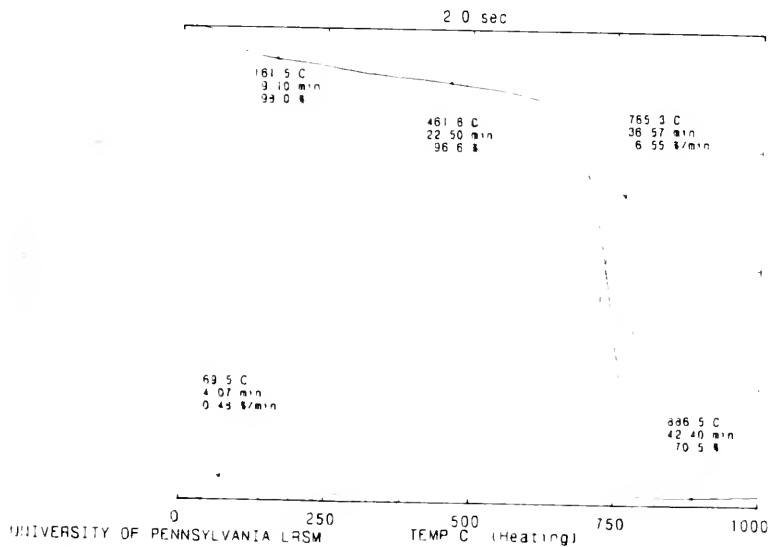
13.4.1. Sample ER 1 (top) compared with Standard for White Portland Cement and Lime (bottom)

17% CO₂ + 10 mg starting weight of sample ER 1 = 1.7 mg CO₂

$$\frac{1.7 \text{ mg CO}_2 \times 100 \text{ g CaCO}_3}{44 \text{ g CO}_2} = 3.86 \text{ mg}$$

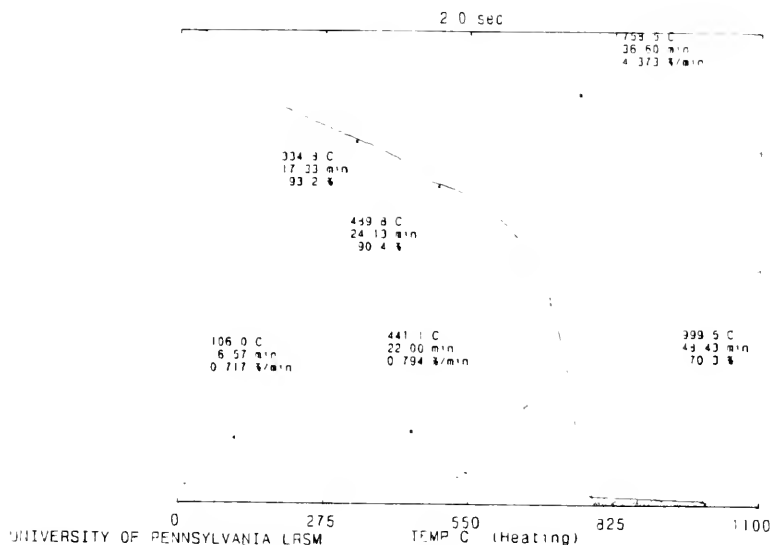
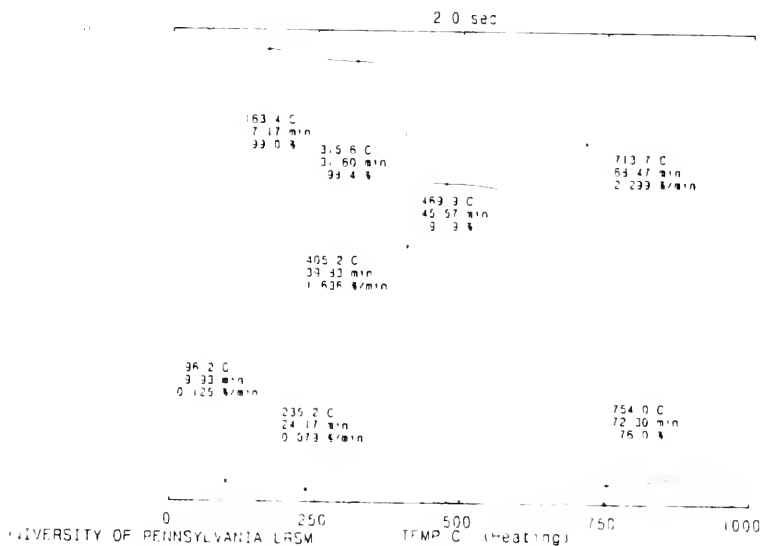
13.4.2. Sample ER 2 (top) compared with Standard for Hydraulic Lime (bottom)

18% CO₂ ÷ 9.8 mg starting weight of sample ER 2 = 1.8 mg CO₂

$$\frac{1.8 \text{ mg CO}_2 \times 100 \text{ g CaCO}_3}{44 \text{ g CO}_2} = 4.09 \text{ mg}$$

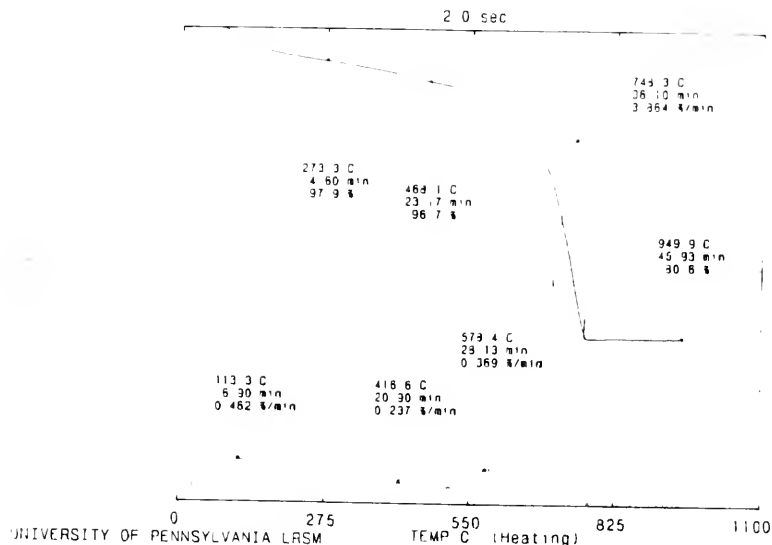
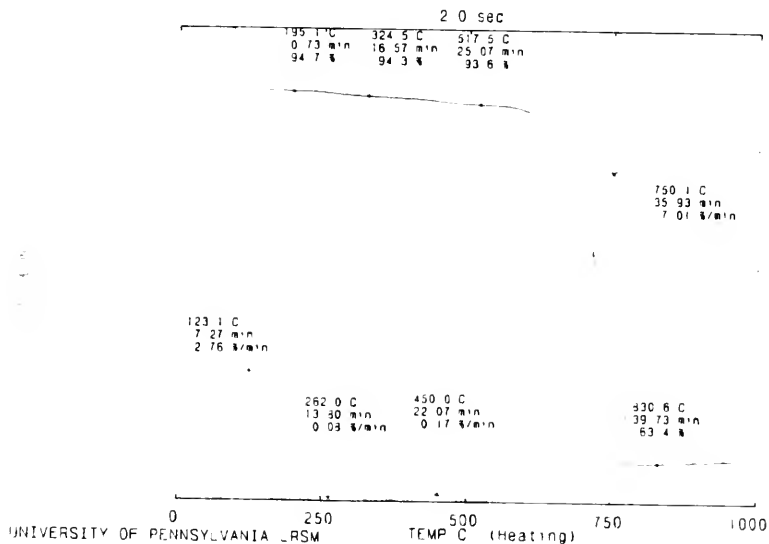
13.4.3. Sample ER 28 (top) compared with
Standard for Lime and Gypsum (bottom)

13% CO₂ ÷ 9.5 mg starting weight of sample ER 28 = 1.3 mg CO₂

$$\frac{1.3 \text{ mg CO}_2 \times 100 \text{ g CaCO}_3}{44 \text{ g CO}_2} = 2.9 \text{ mg}$$

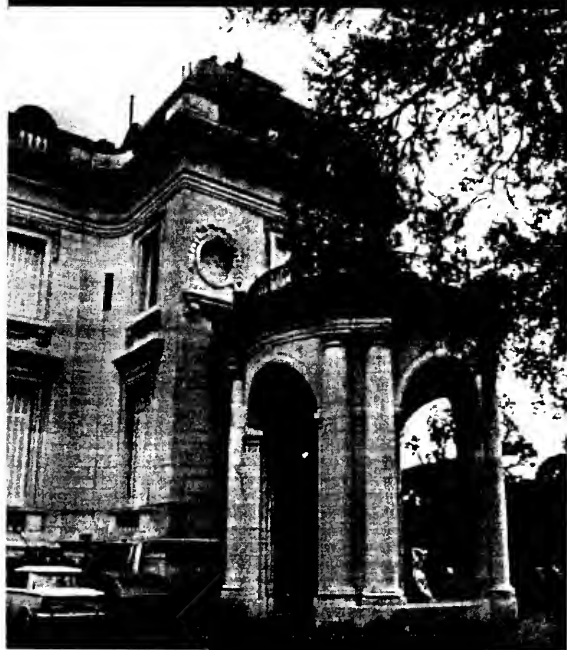
Illustration 8. Palacio Errazuriz,
east entrance and porte-cochere
(view from the southeast).

The tholos of the east entrance is over-painted up to the cornice. As this facade is in the worst condition, removal of the over paint will likely expose bad repairs as well as deterioration and damage. Test treatments are recommended for steam, abrasive, and

chemical paint stripping and cleaning of the entrance. The conditions visible now are abrasion and impact loss, delamination and scaling, as well as irregular loss of partial paint layers due to water penetration.

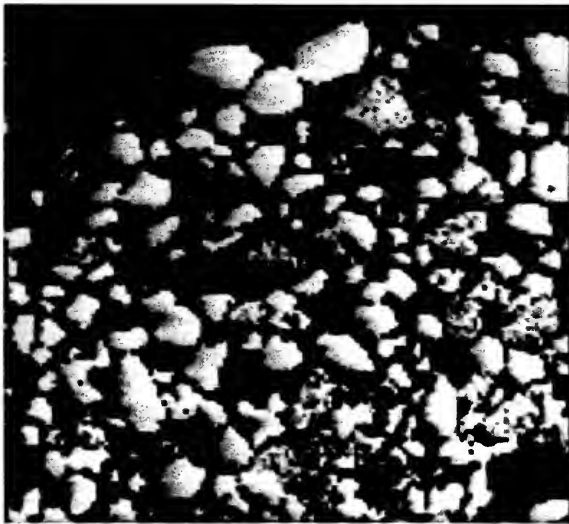
Illustration 18. Sample ER 28, SEM/EDX silicon mapping in cross section. Highlighted areas indicate silicon-rich aggregate.
